Manhole Inspection Summary

Manhole # S21Y__012MH

Insp Date: **11/24/08 1:24 PM**

Location Address: **2027 HOLLINS FERRY RD**

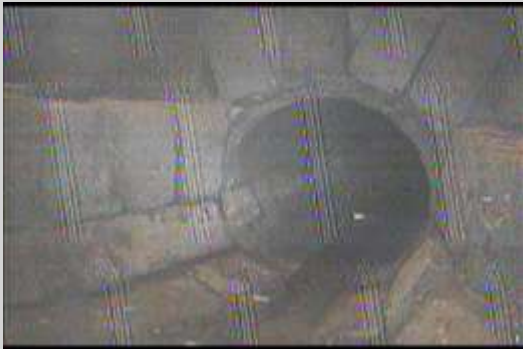
12 O'Clock Outflow

8 in. Circular Gravity Sewer
Pipe Out @ 12 O'Clock

Pipe Height: **8.4** (in.) Rod and Bar (Angled)
Pipe Material: **Clay** ☐ Pipe Lined
Invert Depth: **11.65** (ft.) Flow Characteristics: **Slow**
Deposits: ☒ None ☐ **Mud** ☐ Sludge ☐ **Debris** ☐ Grease
Silt Depth: **0** (in.) Deposits Extent:
Infiltration: **None** Pipe Seal Cond: **Sound**

Drop: **None**

Connects To: **Manhole**

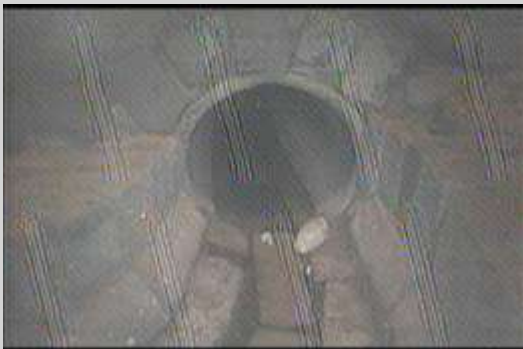
3 O'Clock Inflow

8 in. Circular Gravity Sewer
Pipe In @ 3 O'Clock

Pipe Height: **8.4** (in.) Rod and Bar (Angled)
Pipe Material: **Clay** ☐ Pipe Lined
Invert Depth: **11.51** (ft.) Flow Characteristics: **Slow**
Deposits: ☒ None ☐ **Mud** ☐ Sludge ☐ **Debris** ☐ Grease
Silt Depth: **0** (in.) Deposits Extent:
Infiltration: **None** Pipe Seal Cond: **Sound**

Drop: **None**
